# Manhole Inspection Summary

Manhole # S23GG2009MH

Insp Date: **11/28/06 7:54 AM**

**Location** Address: **904 BELLEMORE RD**

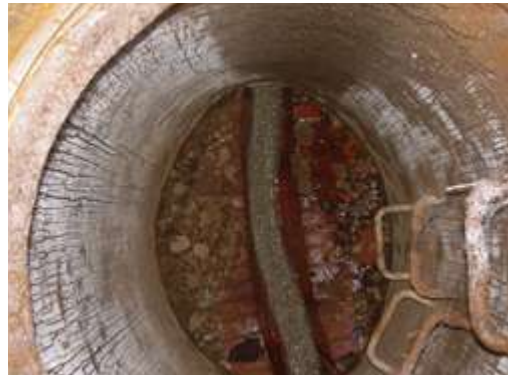
Top View

Corroded steps. Evidence of surcharge - Bench debris.

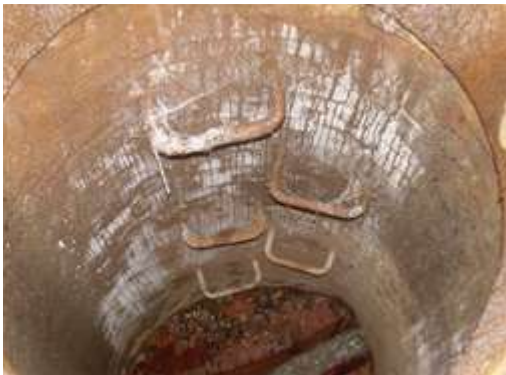
Defect

Adjustment and Barrel infiltration.  
Corroded steps.

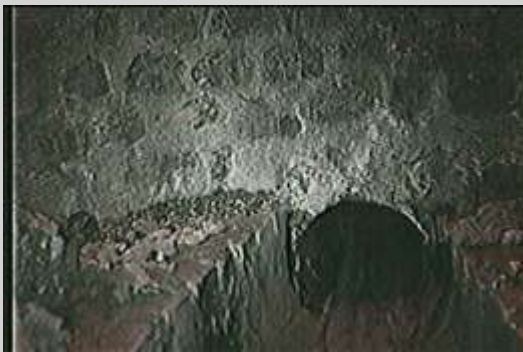
### 8 in. Circular Gravity Sewer Pipe Out @ 12 O'Clock

Infiltration: **Evidence** Pipe Seal Cond: **Unknown**

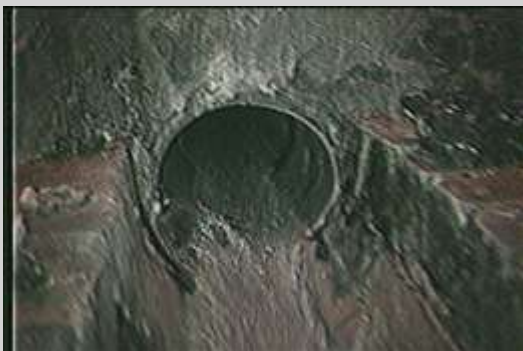
### 8 in. Circular Gravity Sewer Pipe In @ 5 O'Clock

Infiltration: **Gusher** Pipe Seal Cond: **Unknown**
